Putting **FLORIDA** Back Together

Midwest Contractors Team Up To Repair Hurricane-Damaged Bridge

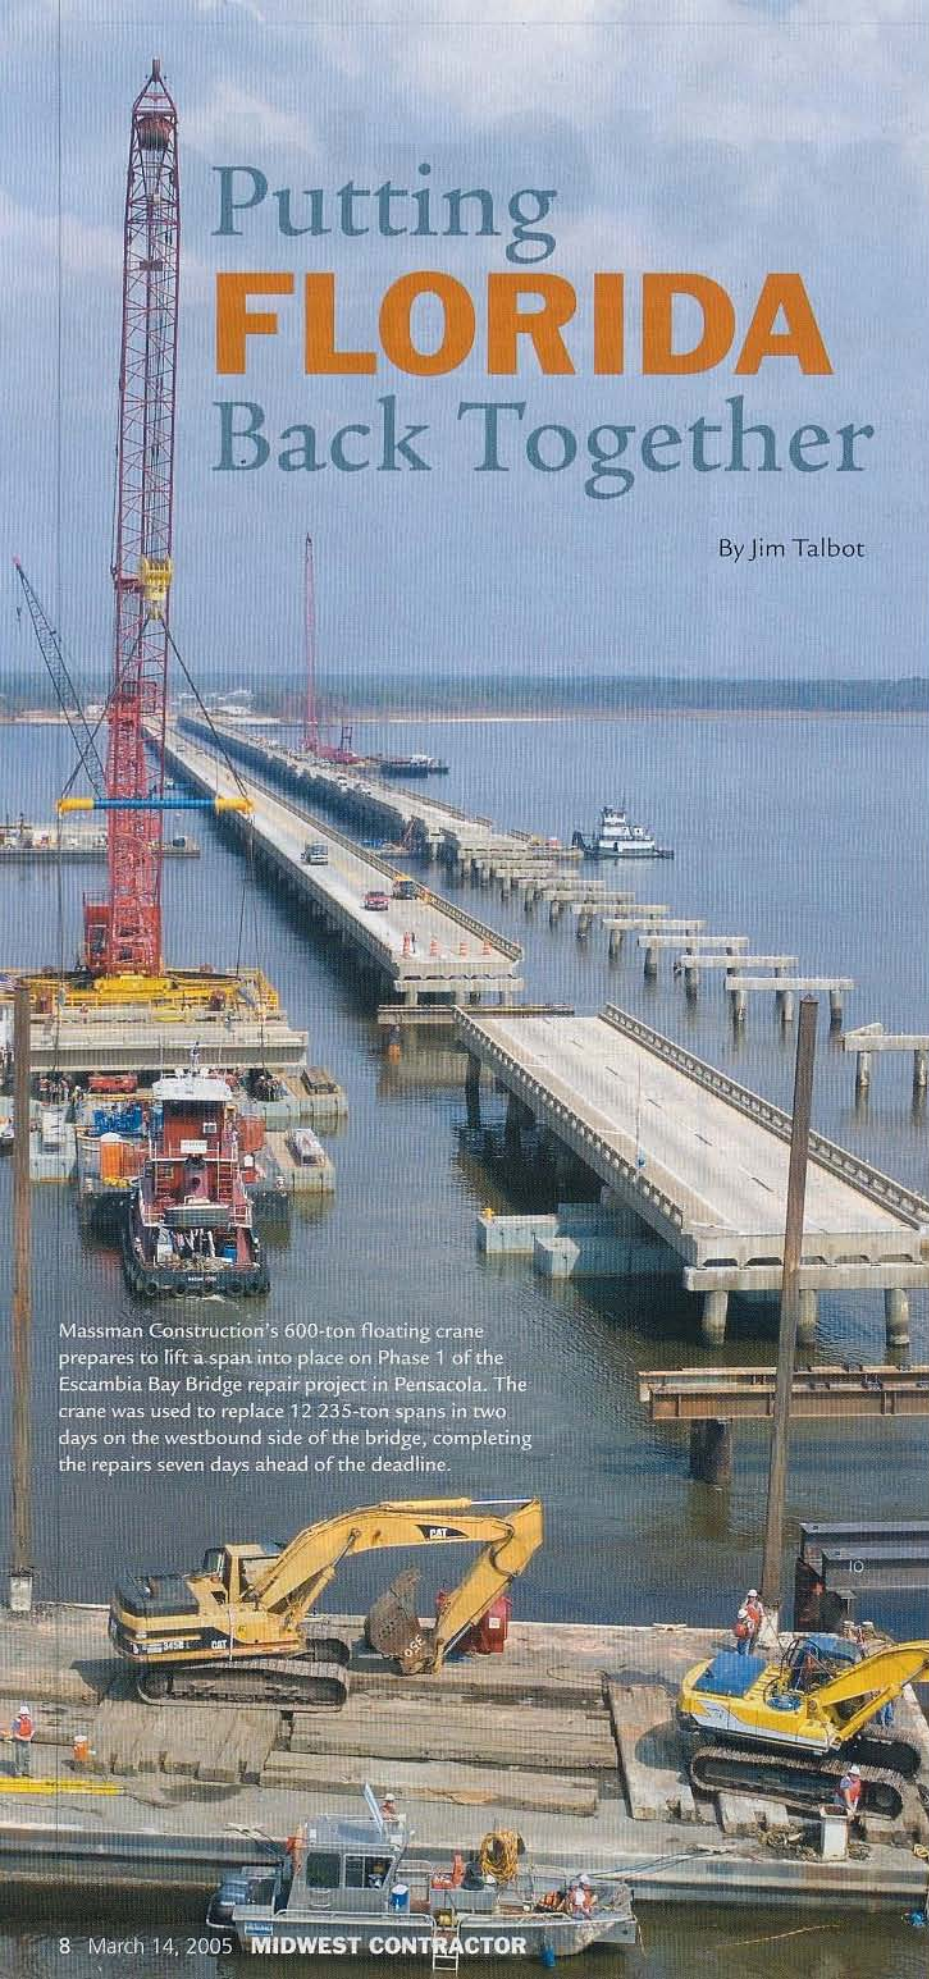
Massman Construction's 600-ton floating crane prepares to lift a span into place on Phase 1 of the Escambia Bay Bridge repair project in Pensacola. The crane was used to replace 12 235-ton spans in two days on the westbound side of the bridge, completing the repairs seven days ahead of the deadline.

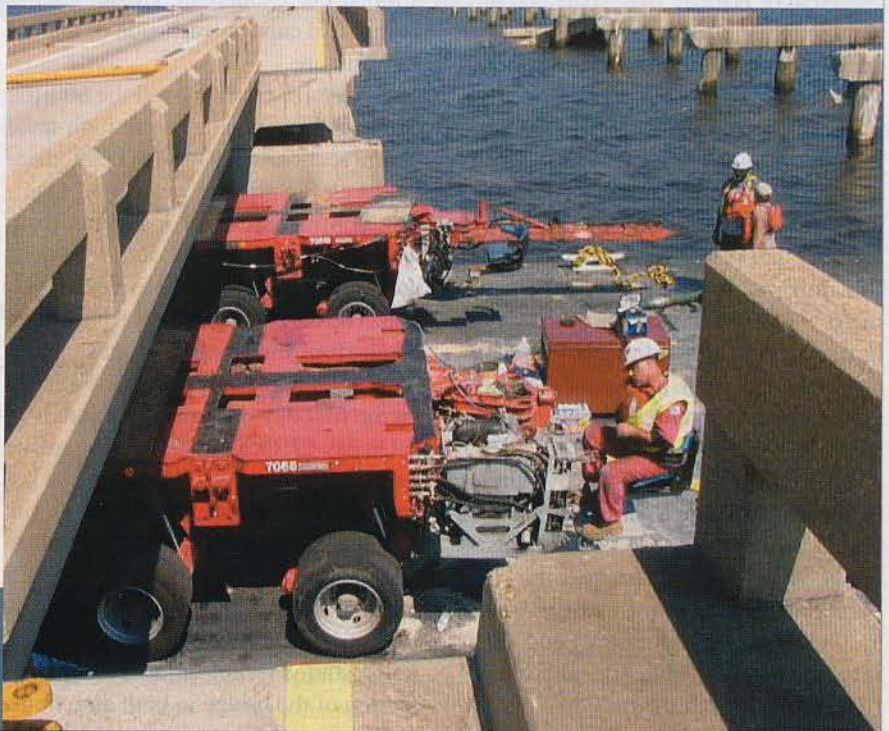
Specialized hydraulic Goldhofer platform trailers on a barge are used to lift and remove span 43 from the eastbound side. The span was moved and set into westbound Span 61.

On day 13, a specialized hydraulic Goldhofer trailer on a barge was used to lift and remove span 43 on the eastbound side. Workers strapped it to the barge, and tugboats pushed the barge around to the westbound side and set it into westbound Span 61. The barge floated the span to the only gap on the

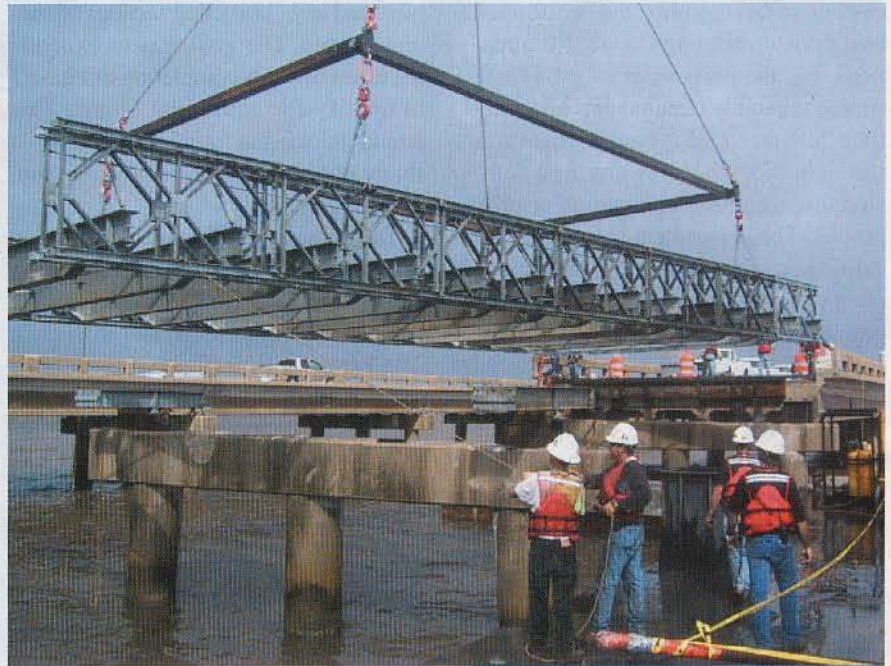
One of the 60-foot prefabricated steel Acrow bridge sections is lifted into place during the Phase 2 repair of the eastbound lanes.

Phase 2 called for the contractor to repair the eastbound bridge with existing spans and steel Acrow sections within 90 days of the signing. The original plan was to create alternating existing spans consisting of 60 feet of concrete and an open 60-foot hole. A total of 7,000 feet of prefabricated Acrow bridge system would span across the entire alternating concrete/gap system of the bridge.
