Putting **FLORIDA** Back Together

Midwest Contractors Team Up To Repair Hurricane-Damaged Bridge

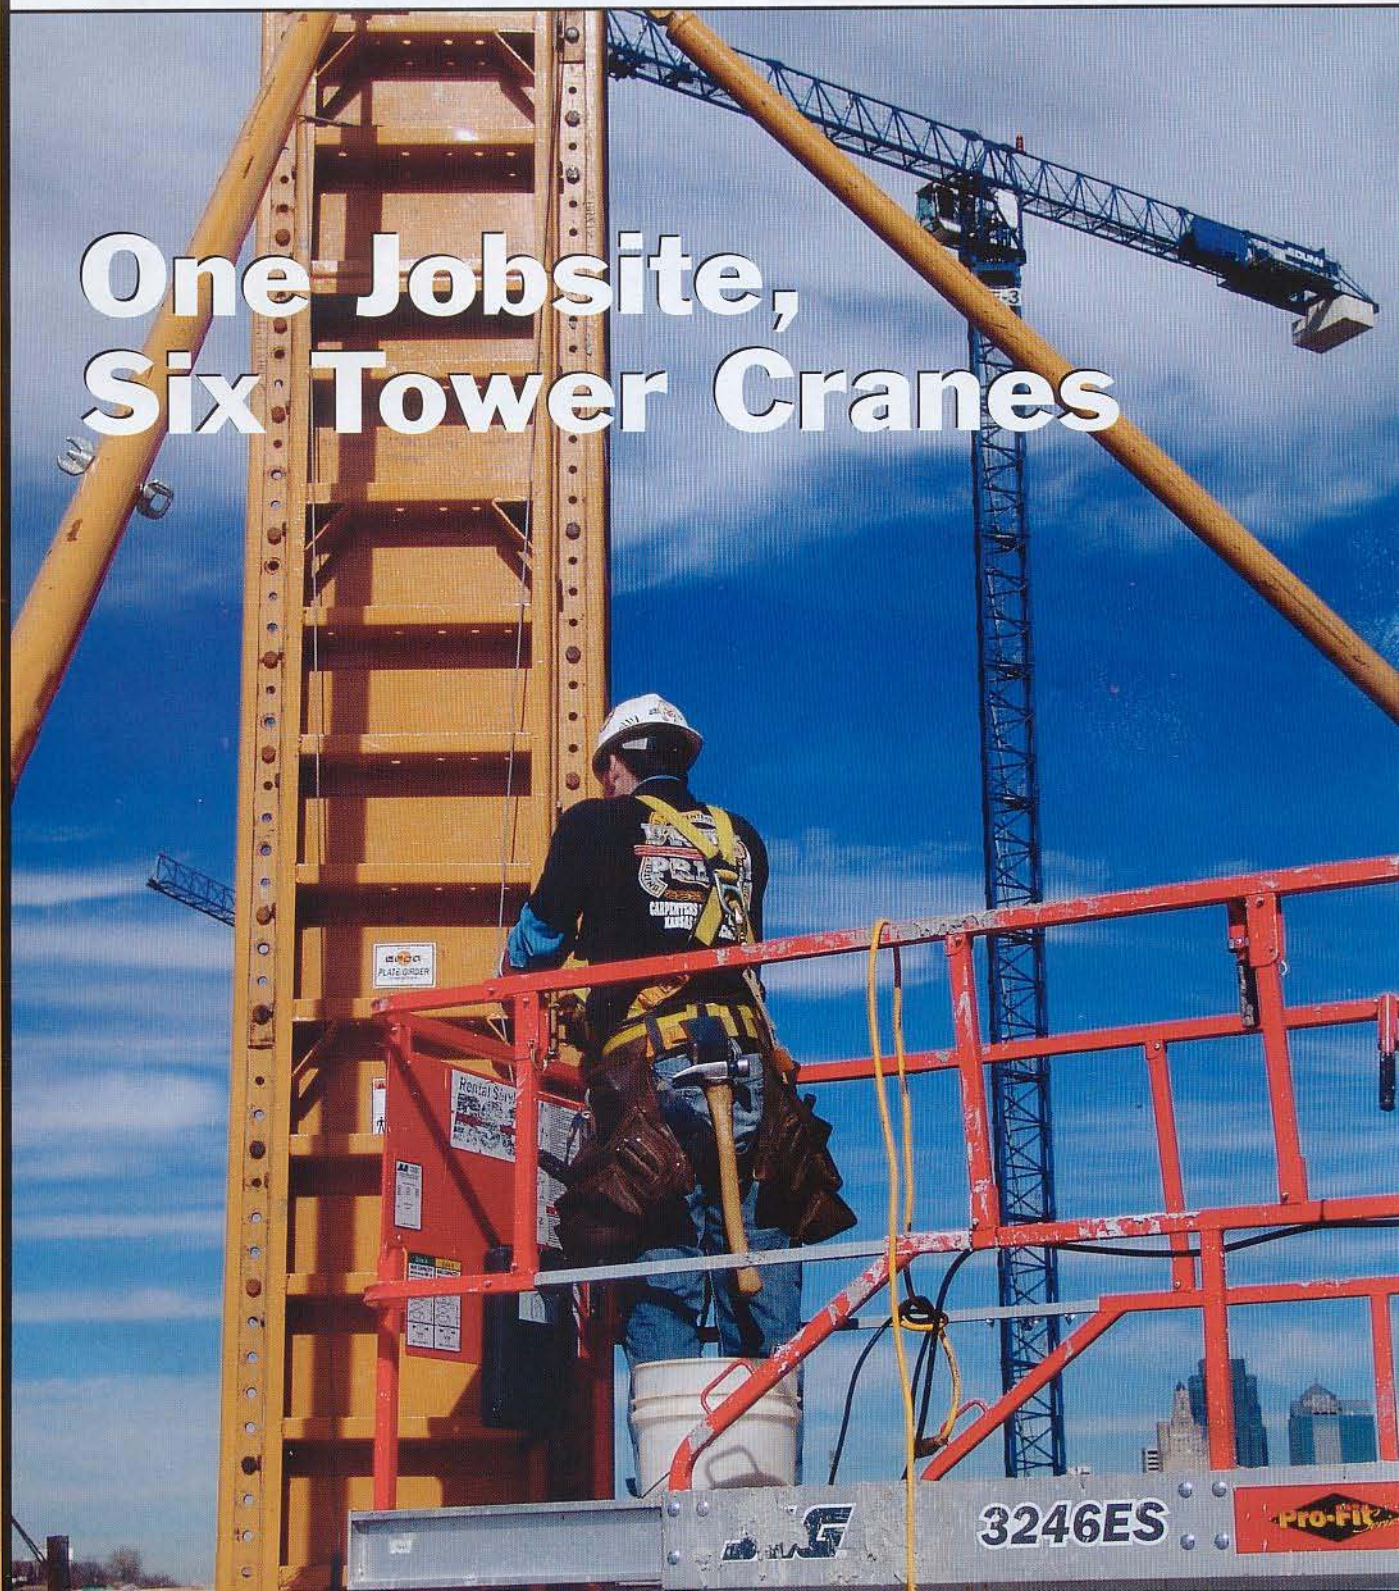
Massman Construction's 600-ton floating crane prepares to lift a span into place on Phase 1 of the Escambia Bay Bridge repair project in Pensacola. The crane was used to replace 12 235-ton spans in two days on the westbound side of the bridge, completing the repairs seven days ahead of the deadline.
